## SITE CLASSIFICATION REPORT GT19-253-001R REV 1 LOT 16 MARLOW COURT, GEORGETOWN QLD 4871

<b>CUSTOMER:</b>	Etheridge Shire Council	<b>REPORT:</b>	GT19-253-001R Rev.1
<b>POSTAL ADDRESS:</b>	PO Box 12 Georgetown QLD 4871	<b>DATE:</b>	29 <sup>th</sup> August 2019
<b>INSPECTION DATE:</b>	28 <sup>th</sup> August 2019	<b>ORDER No:</b>	84315/2
		<b>RPEQ NO:</b>	4449

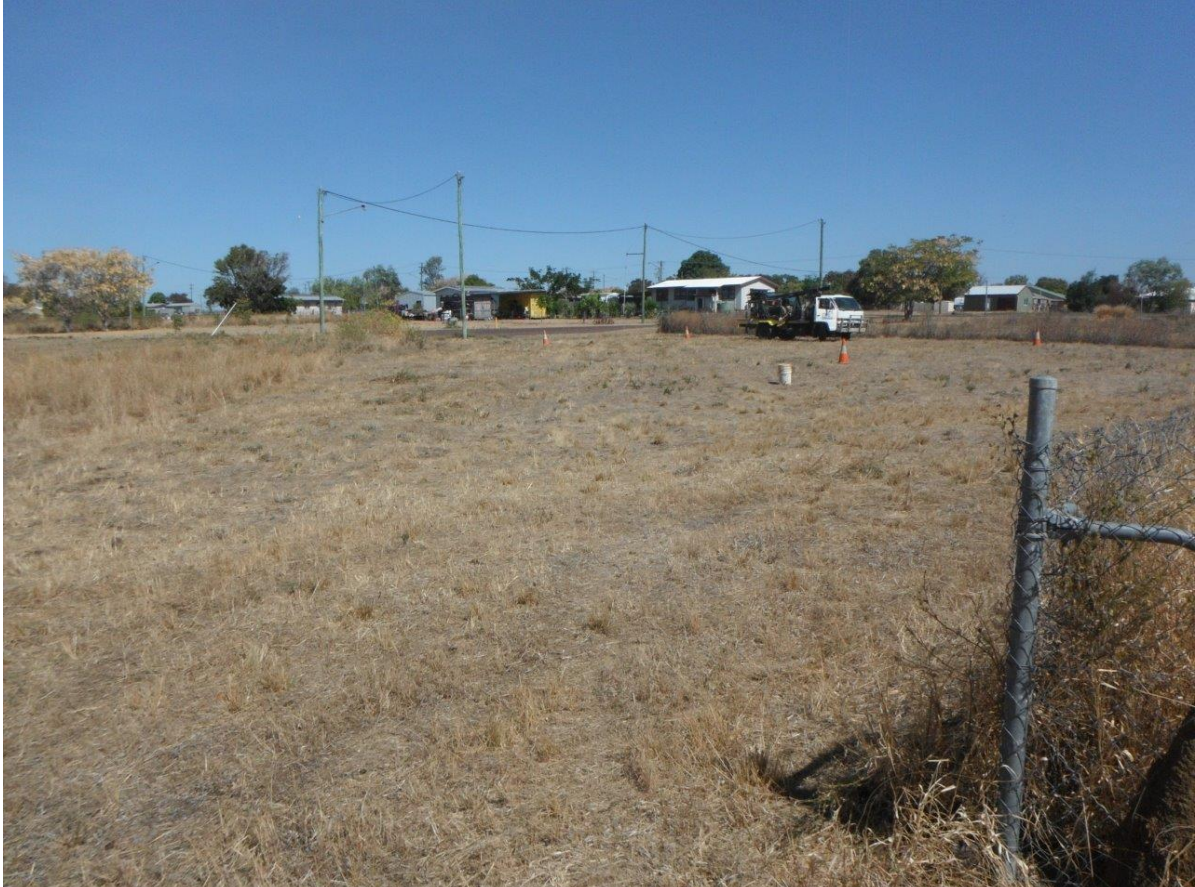
- a. **Vegetation:** The proposed development site was covered by thick, short grass and sparse shrubs.
- b. **Slope:** The proposed development area is described as slightly sloping at 5 degrees in the eastern direction.
- c. **Water Table:** At the time of the investigation, groundwater was not encountered in the excavated boreholes. However, it should be noted, that groundwater levels are affected by climatic conditions, tidal fluctuations and by soil permeability, therefore groundwater levels may vary with time.
- d. **Other Significant Features:** Nil.
- e. **Drainage:** The site was assessed as comprising good drainage conditions.

**Photo of the allotment**
