SITE CLASSIFICATION REPORT GT19-253-003R REV 1 LOT 19 MARLOW COURT, GEORGETOWN QLD 4871

CUSTOMER:	Etheridge Shire Council	REPORT:	GT19-253-003R Rev.1
POSTAL ADDRESS:	PO Box 12 Georgetown QLD 4871	DATE:	29 th August 2019
INSPECTION DATE:	28 th August 2019	ORDER No:	84315/2
		RPEQ NO:	4449

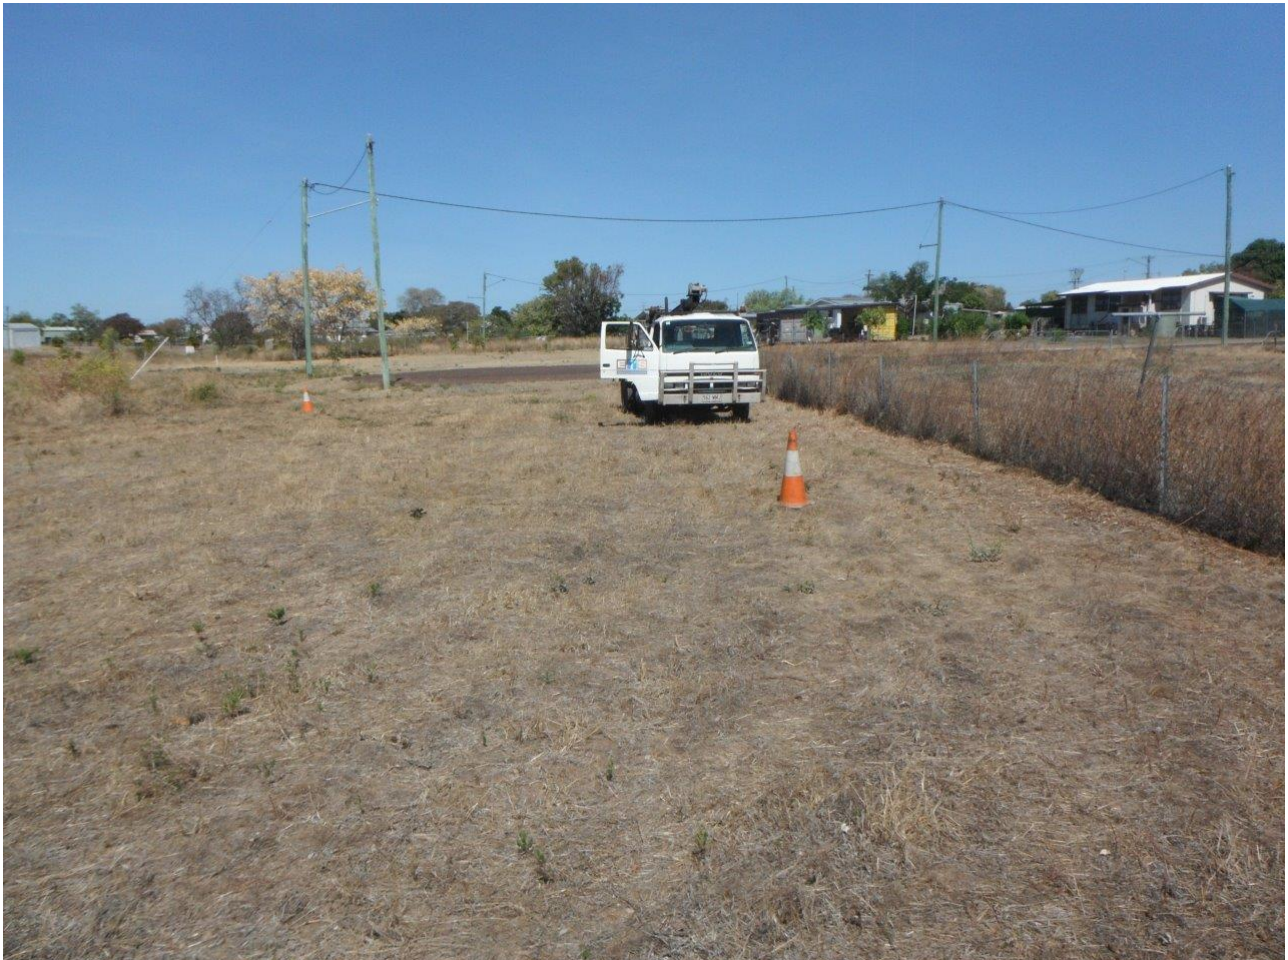
Photo of the allotment

- a. **Vegetation:** The proposed development site was covered by thick, short grass.
- b. **Slope:** The proposed development area is described as slightly sloping between 2 to 5 degrees in the northern direction.
- c. **Water Table:** At the time of the investigation, groundwater was not encountered in the excavated boreholes. However, it should be noted, that groundwater levels are affected by climatic conditions, tidal fluctuations and by soil permeability, therefore groundwater levels may vary with time.
- d. **Other Significant Features:** Nil.
- e. **Drainage:** The site was assessed as comprising good drainage conditions.

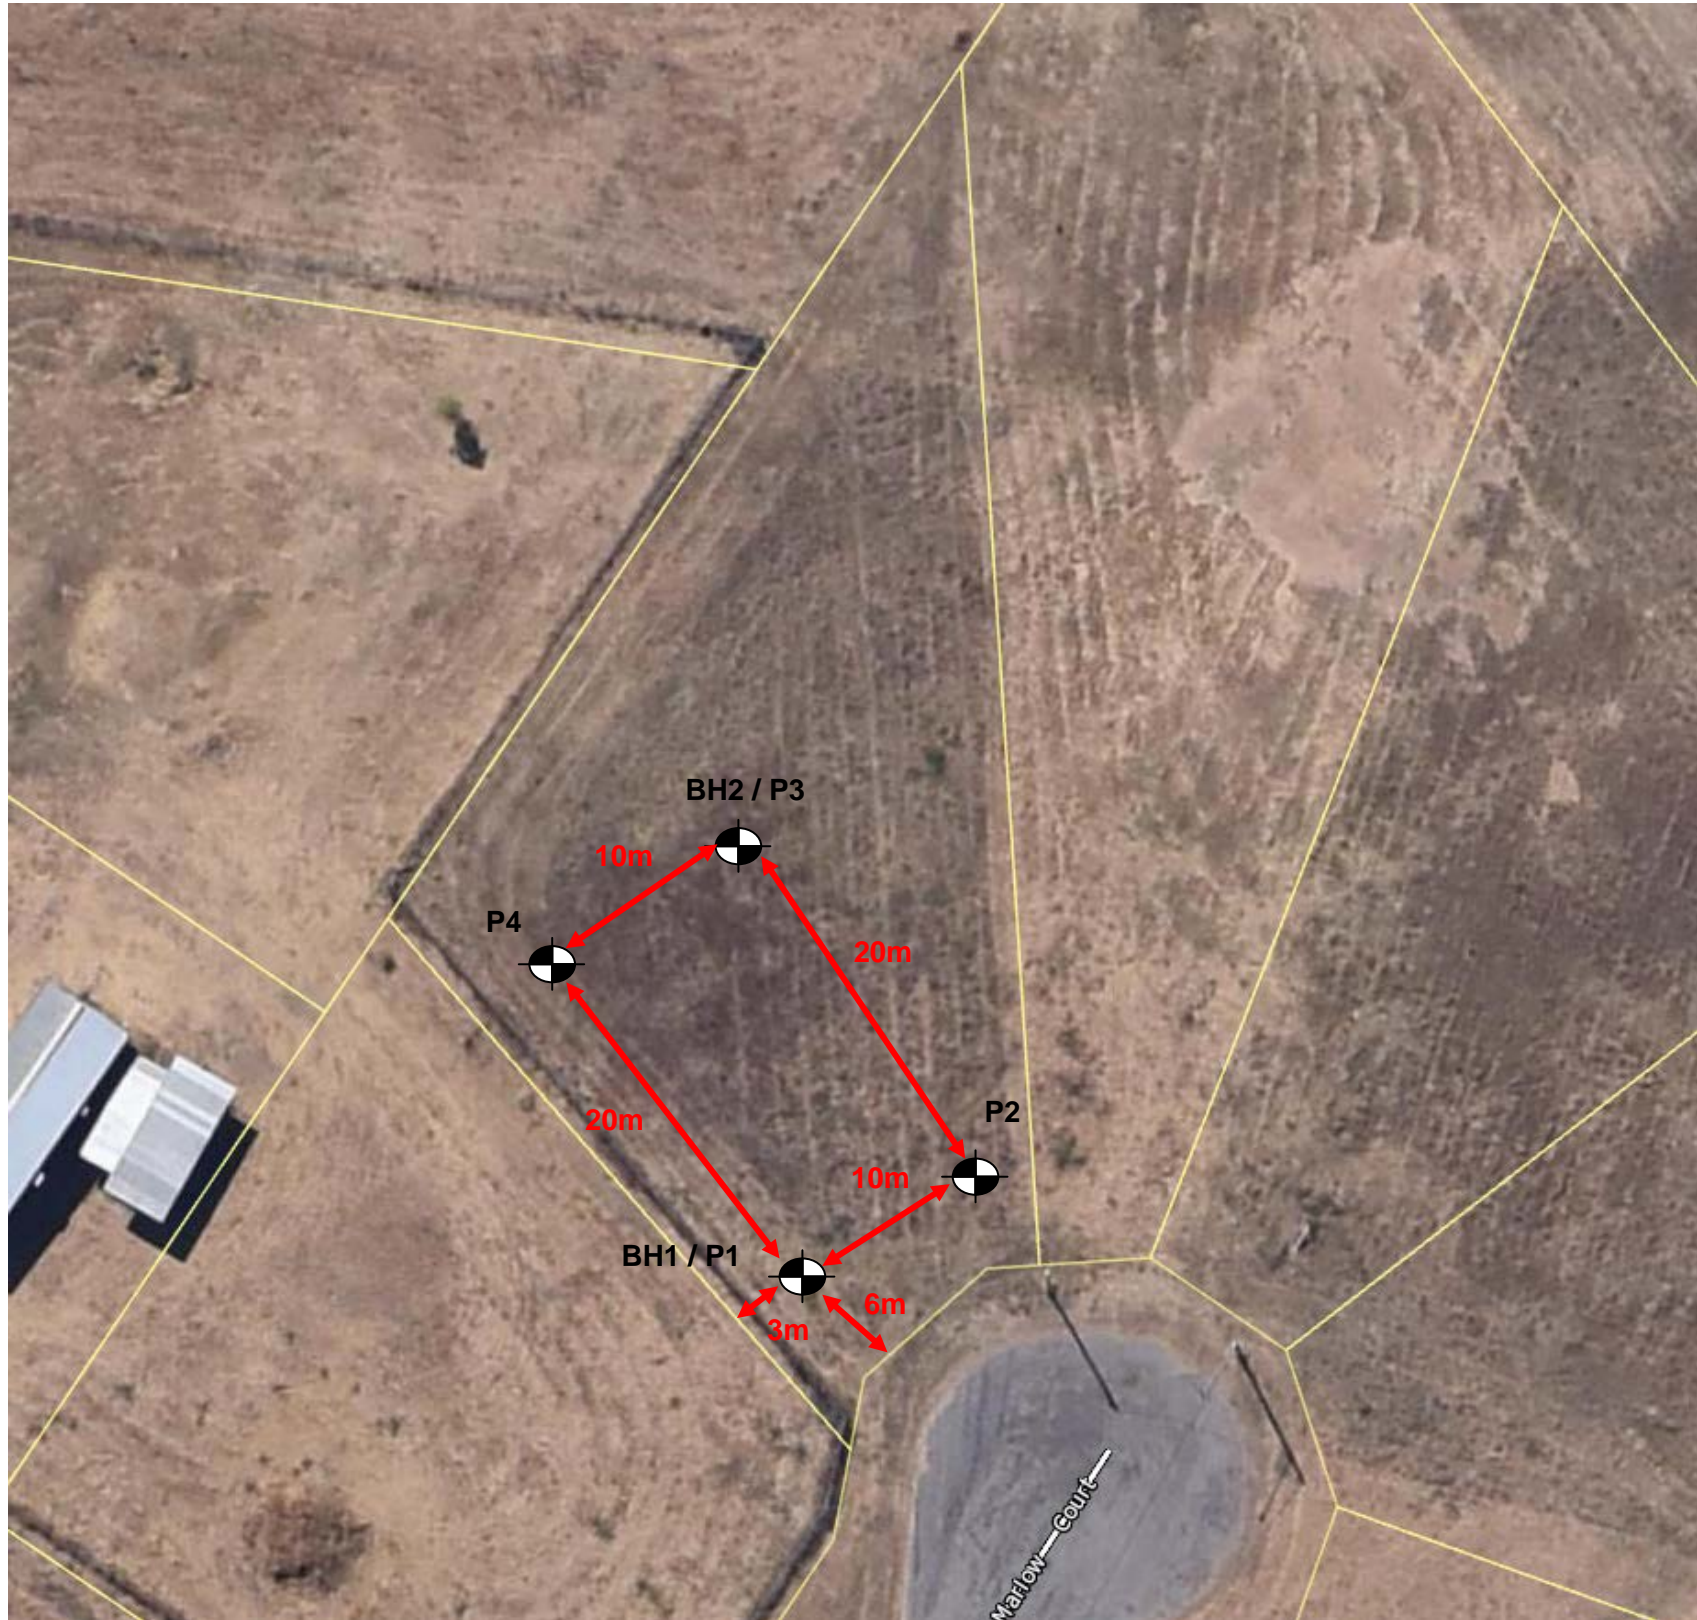
Borehole and DCP Locations

Insitu testing was carried out by Dynamic Cone Penetrometer tests at locations P1 to P4 (see site plan and Dynamic Cone Penetrometer Report enclosed) to evaluate the foundation density conditions.

Two (2) boreholes were excavated using a drill rig to determine the soil profile and recover disturbed samples for laboratory testing (Marked BH1 and BH2 on the Site Plan).
